## **Formation of White Etching Areas during Rolling Contact Fatigue of SAE 52100 Bearing Steel - the Influence of Diffusible Hydrogen**

Oezel, M.O.<sup>1</sup>, Schwedt, A.<sup>2</sup>, Janitzky, T.<sup>1</sup>, Kelley, R.<sup>3</sup>, Bouchet-Marquis, C.<sup>3</sup>, Pullan, L.<sup>3</sup>, Broeckmann, C.<sup>1</sup> and Mayer, J.<sup>2</sup>

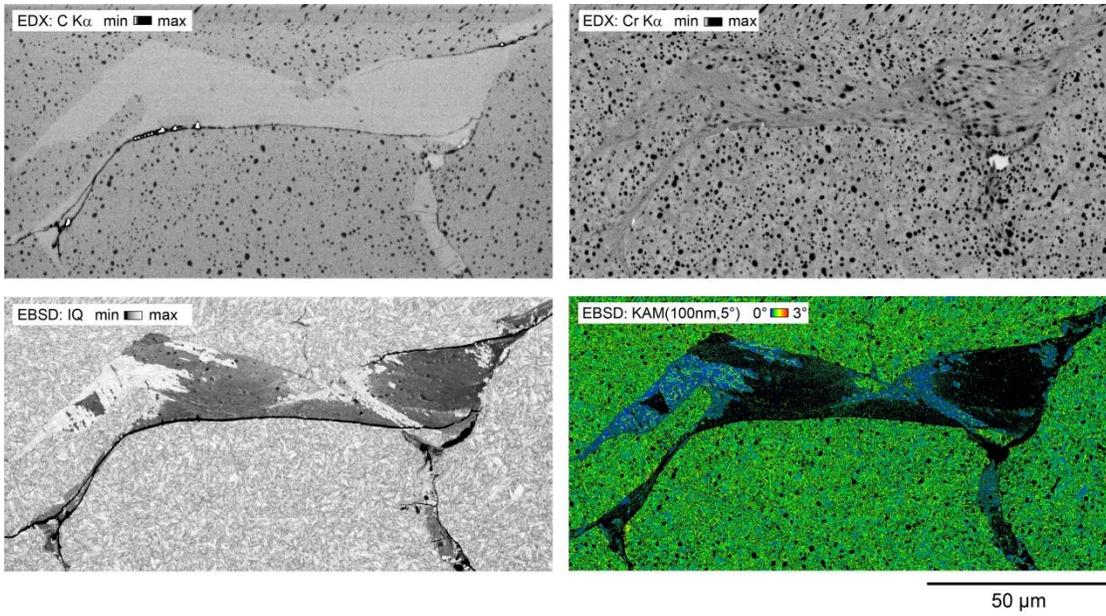
The results of the microstructure analyses (cf. Fig. 1) show a considerable recrystallization and growth of ferritic components in the course of the microstructure alterations. Cracks are mostly found laterally at the boundaries between altered microstructure and unaltered matrix. In order to better understand the spatial relation between cracks and microstructure alterations, the analytical approach has been extended by a 3D PFIB analysis of a (100 micron)<sup>3</sup> cube containing both, cracks and microstructurally altered regions. Also in 3D (cf. Fig. 2), the cracks are preferably found at the sides of the altered areas. Altered regions without any connection to a crack could also be found.

Fig. 1: Microstructure alterations in the cross section of a sample tested for 8.2h (raceway horizontally above the images)

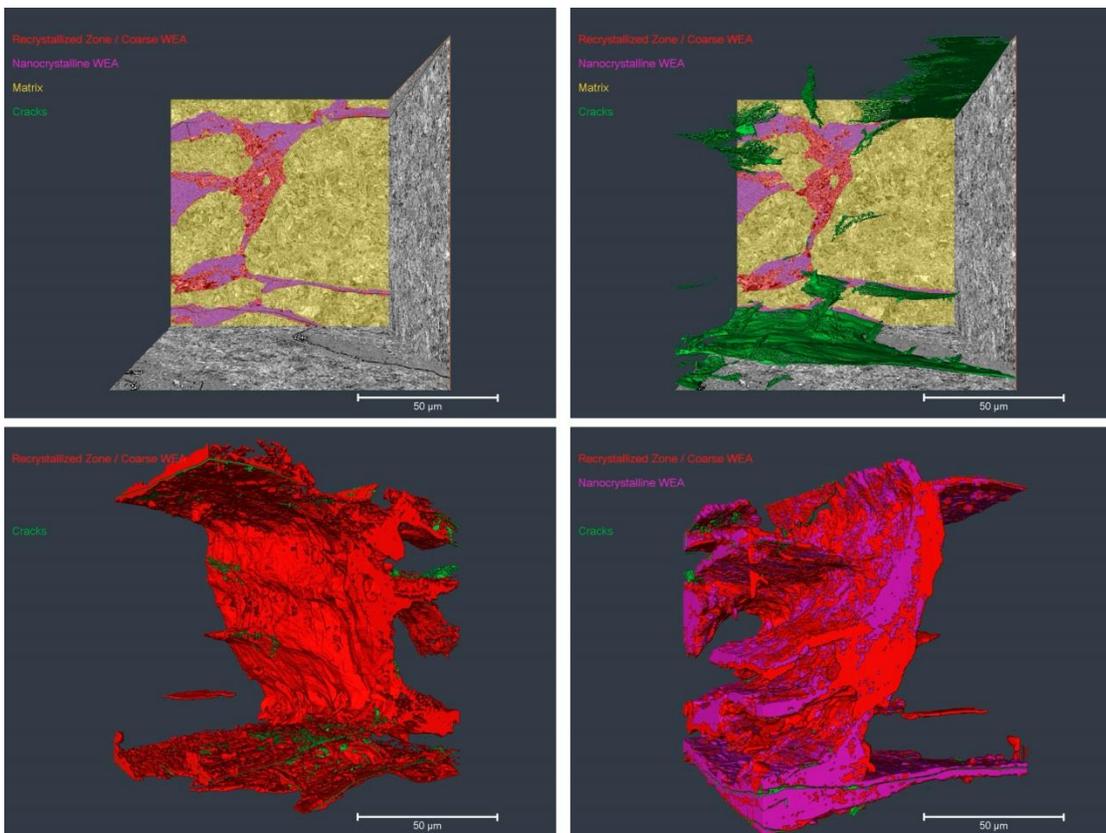
Fig. 2: 3D PFIB reconstruction and segmentation of another altered area from the same specimen (raceway approx. horizontally below the images).
